PROFESSIONAL BUILDING INSPECTION

Single Family Home

471 Cestaric Drive, Milpitas, CA

March 16, 2010

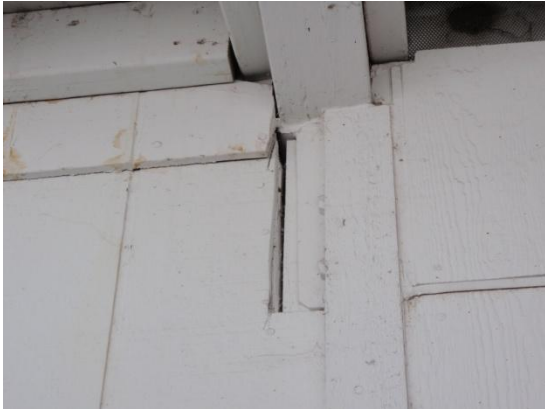
A. The siding is not sealed around the framing at the rear north side of the building. SEE PHOTO SUMMARY.

The siding is not sealed around the framing at the rear north side of the building.

It is suggested that the siding be repaired.

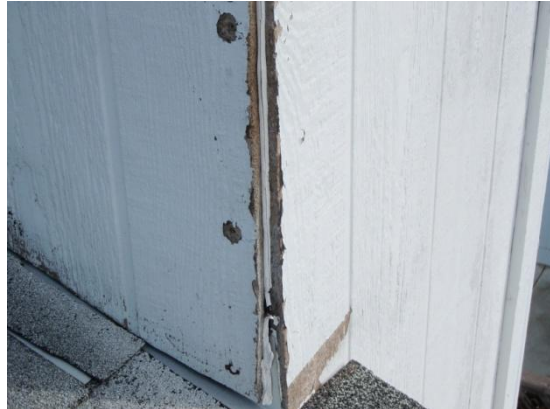
The chimney trim is loose and missing. It is suggested that the condition be corrected.
SEE PHOTO SUMMARY

The chimney trim is loose and missing.

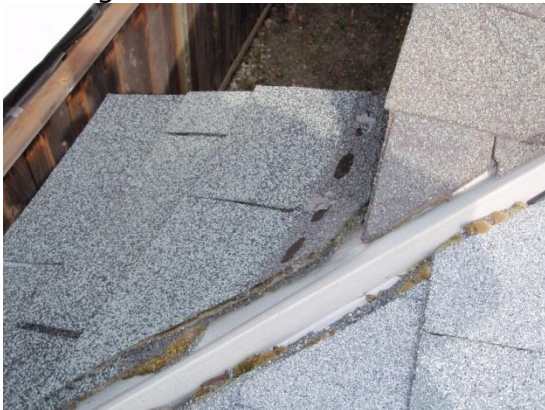
The composition shingle roof covering for the building has evidence that suggests **CORRECTIVE WORK SHOULD BE PERFORMED** at this time because the roof covering is improperly installed at several locations. It is recommended that a competent roofing contractor be consulted for recommendations and corrective work. SEE PHOTO SUMMARY

The roof covering is improperly installed at several locations.

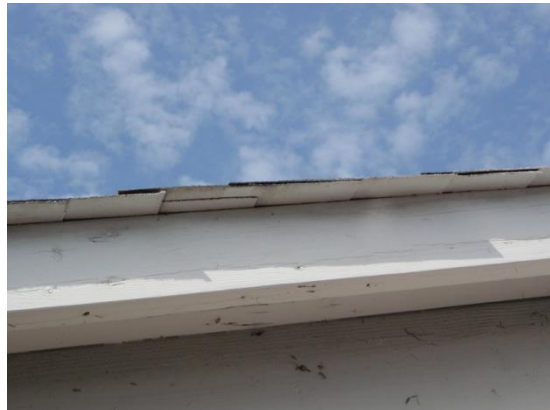
- A. Edge flashing is not provided at the front, front north and rear south sides of the building. SEE PHOTO SUMMARY
- B. The flashing at several locations at the rear addition is not installed in accordance with best industry practices. The present method of installation could result in leakage. SEE PHOTO SUMMARY

Edge flashing is not provided at the front, front north and rear south sides of the building.

It is recommended that a competent roofing contractor be consulted for recommendations and corrective work.

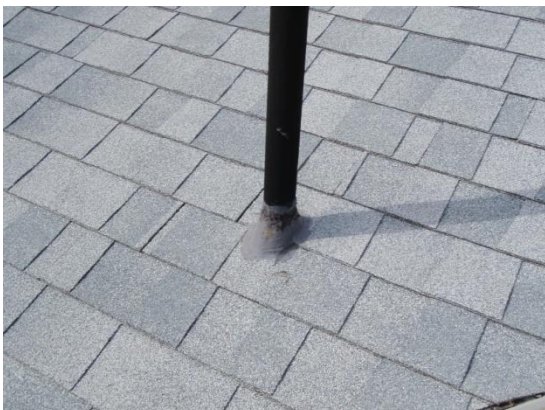
The flashing at several locations at the rear addition is not installed in accordance with best industry practices.

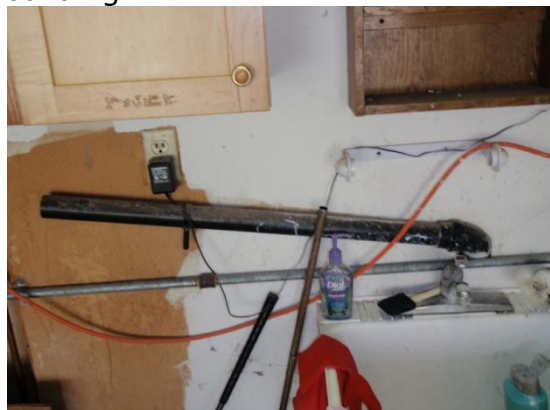
A. The washing machine drain and the drainage piping in the master bathroom sink cabinet is an improper design. SEE PHOTO SUMMARY

The washing machine drain is an improper design.

It is recommended that a competent plumbing contractor be consulted for recommendations and corrective work.

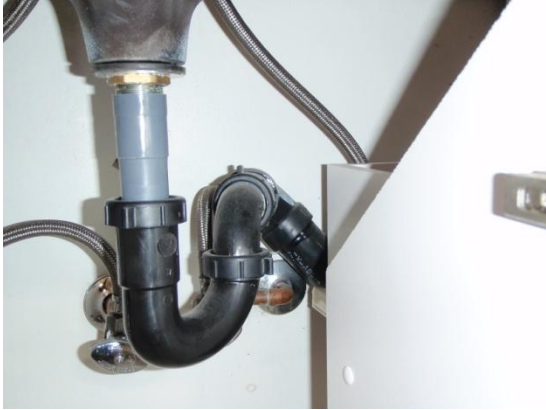
The drainage piping in the master bathroom sink cabinet is an improper design.

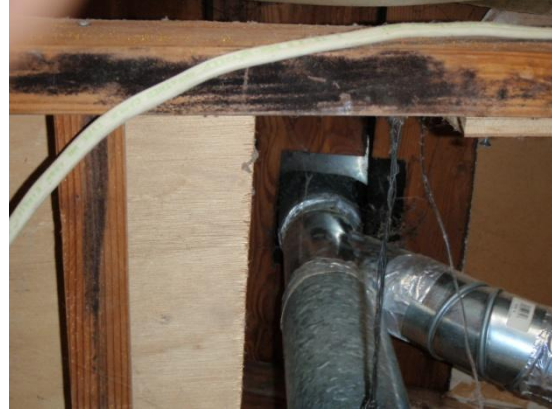
- A. The discharge piping for the temperature/pressure relief valve terminates improperly and the diameter is undersized. The code requires that this safety valve have a rigid piped system to deliver the discharged water to a safe location to avoid accidental personal injury.
- B. The distance between the flue and combustible materials is insufficient at the roof.
SEE PHOTO SUMMARY

The distance between the flue and combustible materials is insufficient at the roof.

It is recommended that a competent plumbing contractor be consulted for recommendations and corrective work.
