Property Inspection Service

PROFESSIONAL BUILDING INSPECTION

Single Family Home

1574 Theo Drive, San Jose, CA

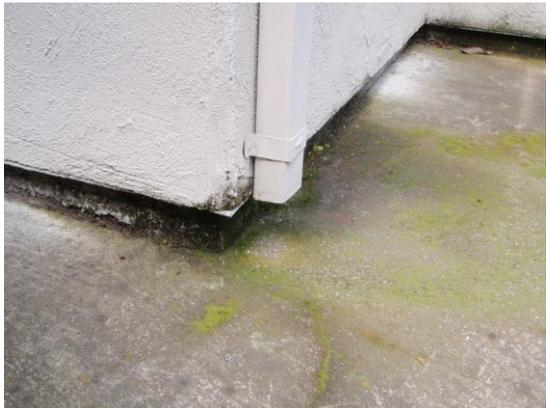
The downspout at the rear south corner of the house **SHOULD BE SERVICED** because the bottom elbow is missing. It is suggested that the downspout condition be corrected. SEE PHOTO SUMMARY

The bottom elbow is missing at the rear south corner of the house.

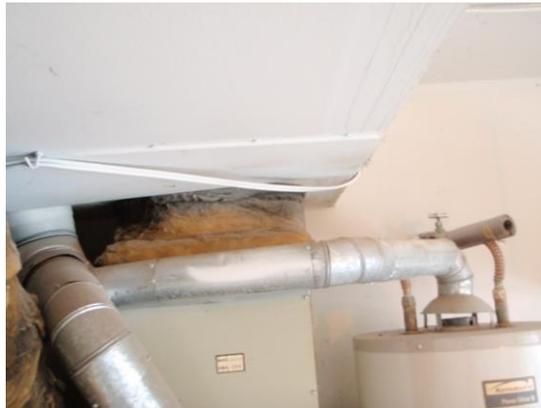
A. The flue to handle flue gases is improperly sloped in the garage. SEE PHOTO SUMMARY

The flue to handle flue gases is improperly sloped in the garage.

It is recommended that a competent plumbing contractor be consulted for recommendations and corrective work.

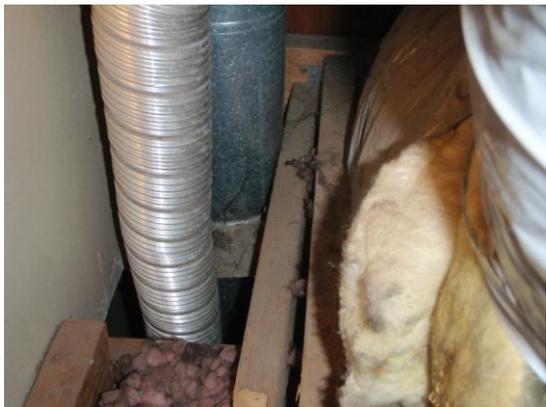
A. The distance between the flue and combustible materials is insufficient in the attic at the framing member above the front left bedroom. SEE PHOTO SUMMARY

The distance between the flue and combustible materials is insufficient in the attic at the framing member above the front left bedroom.

It is recommended that a competent heating contractor be consulted for recommendations and corrective work.
