# Property Inspection Service

PROFESSIONAL BUILDING INSPECTION

## Single Family Home

3940 Bouquet Park Lane, San Jose, CA

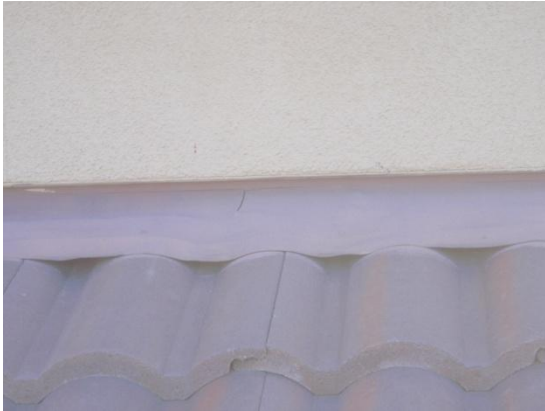
A. There are cracks at the wall to roof flashing above the two car garage. SEE PHOTO SUMMARY

There are cracks at the wall to roof flashing above the two car garage.

It is recommended that a competent roofing contractor be consulted for recommendations and corrective work.
